DYNAMIC SCIENCE, INC.
In-Depth Accident Investigation

Contract DTNH22-94-D-27058
Case DSI-94-SP-007

TECHNICAL SUMMARY

CONTRACTOR: Dynamic Science, Inc.
CONTRACT NUMBER: DTNH22-94-D-27058
CASE NUMBER: Case DSI-94-SP-007

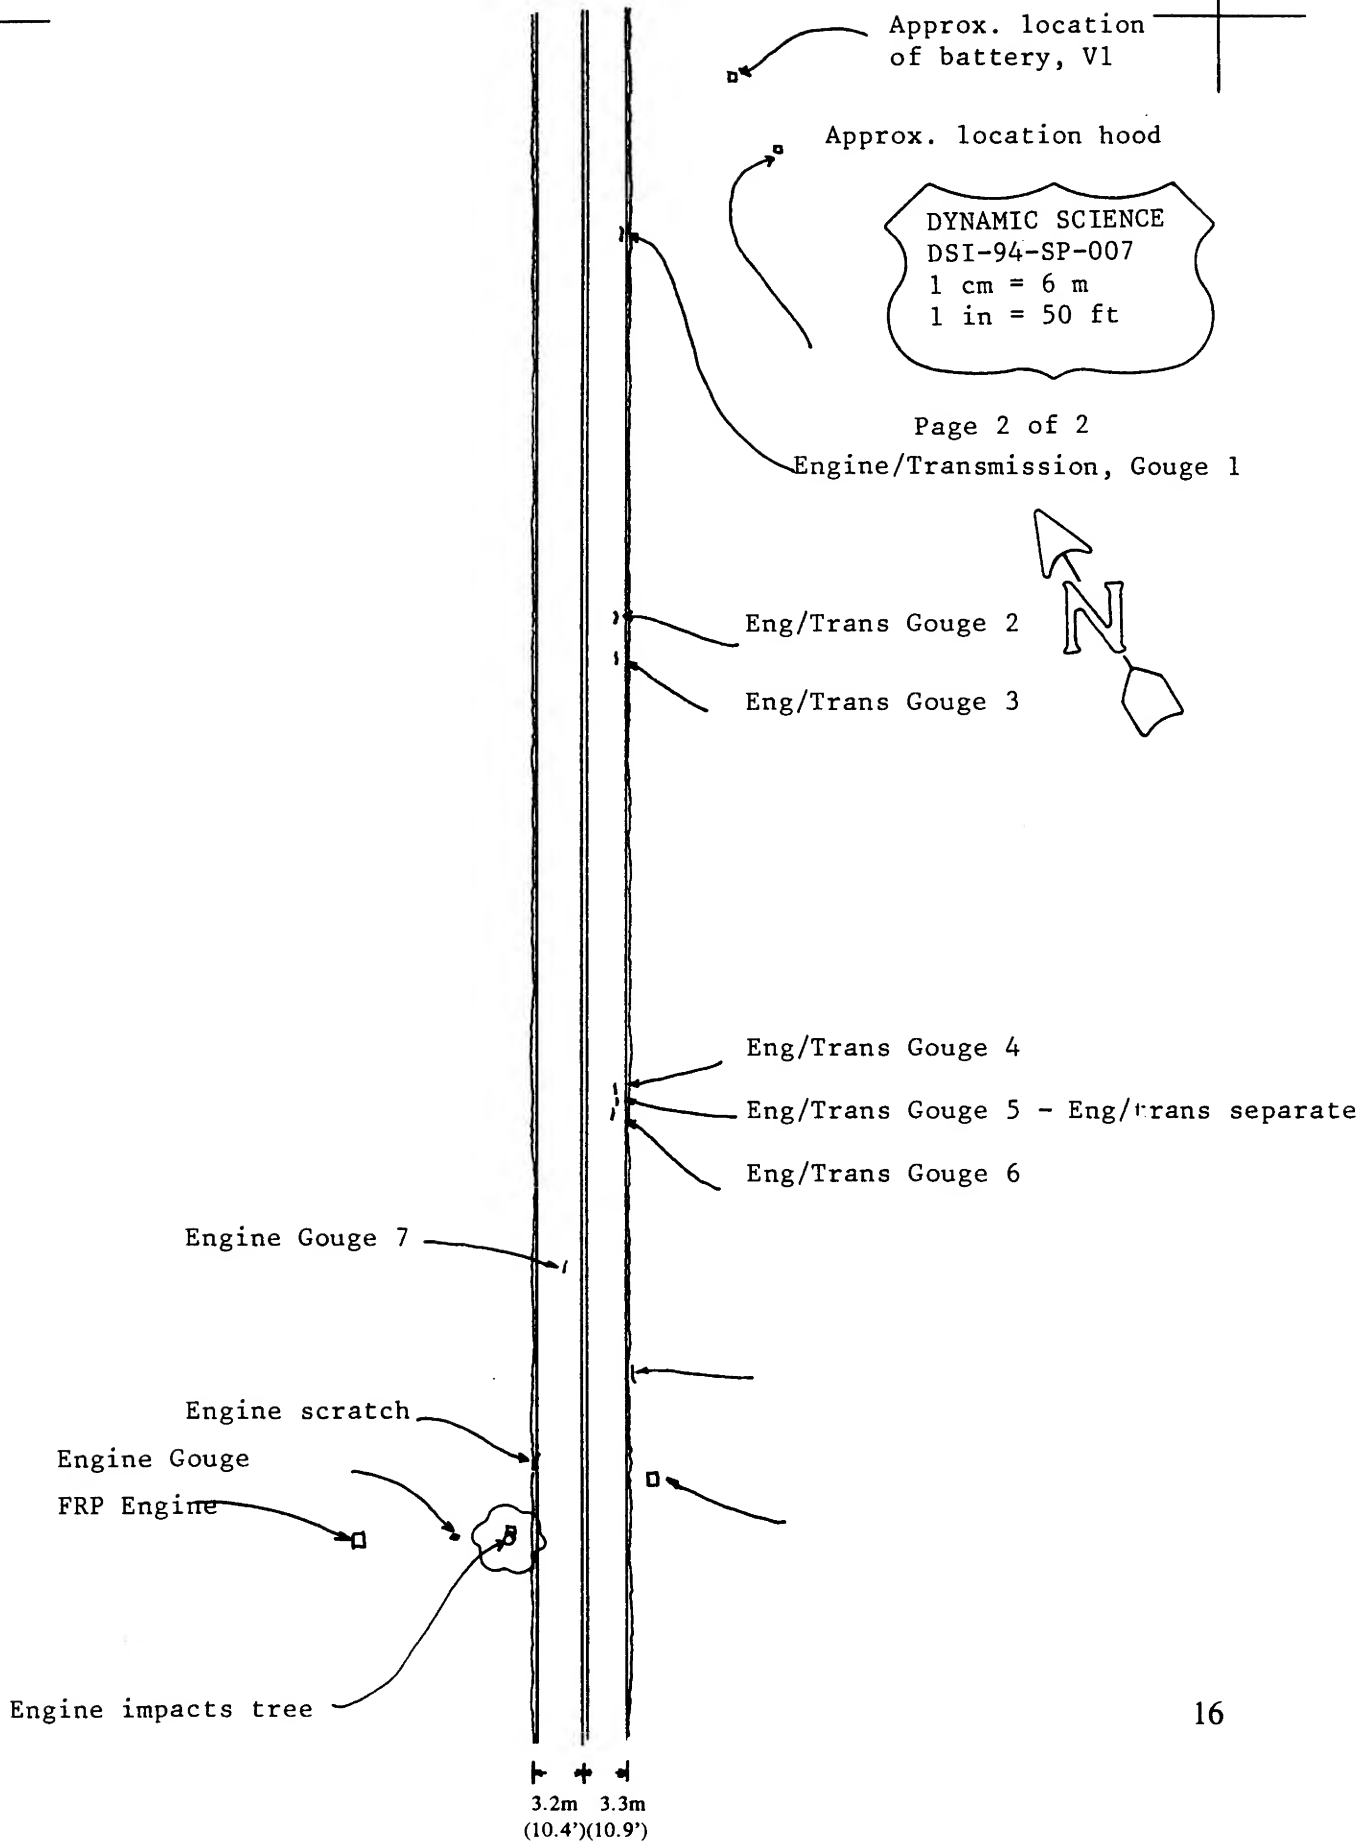
COLLISION MEASUREMENTS

POI # 3 - & FRP 61 cm (24in) tree

3.2m 3.3m
(10.4')(10.9')

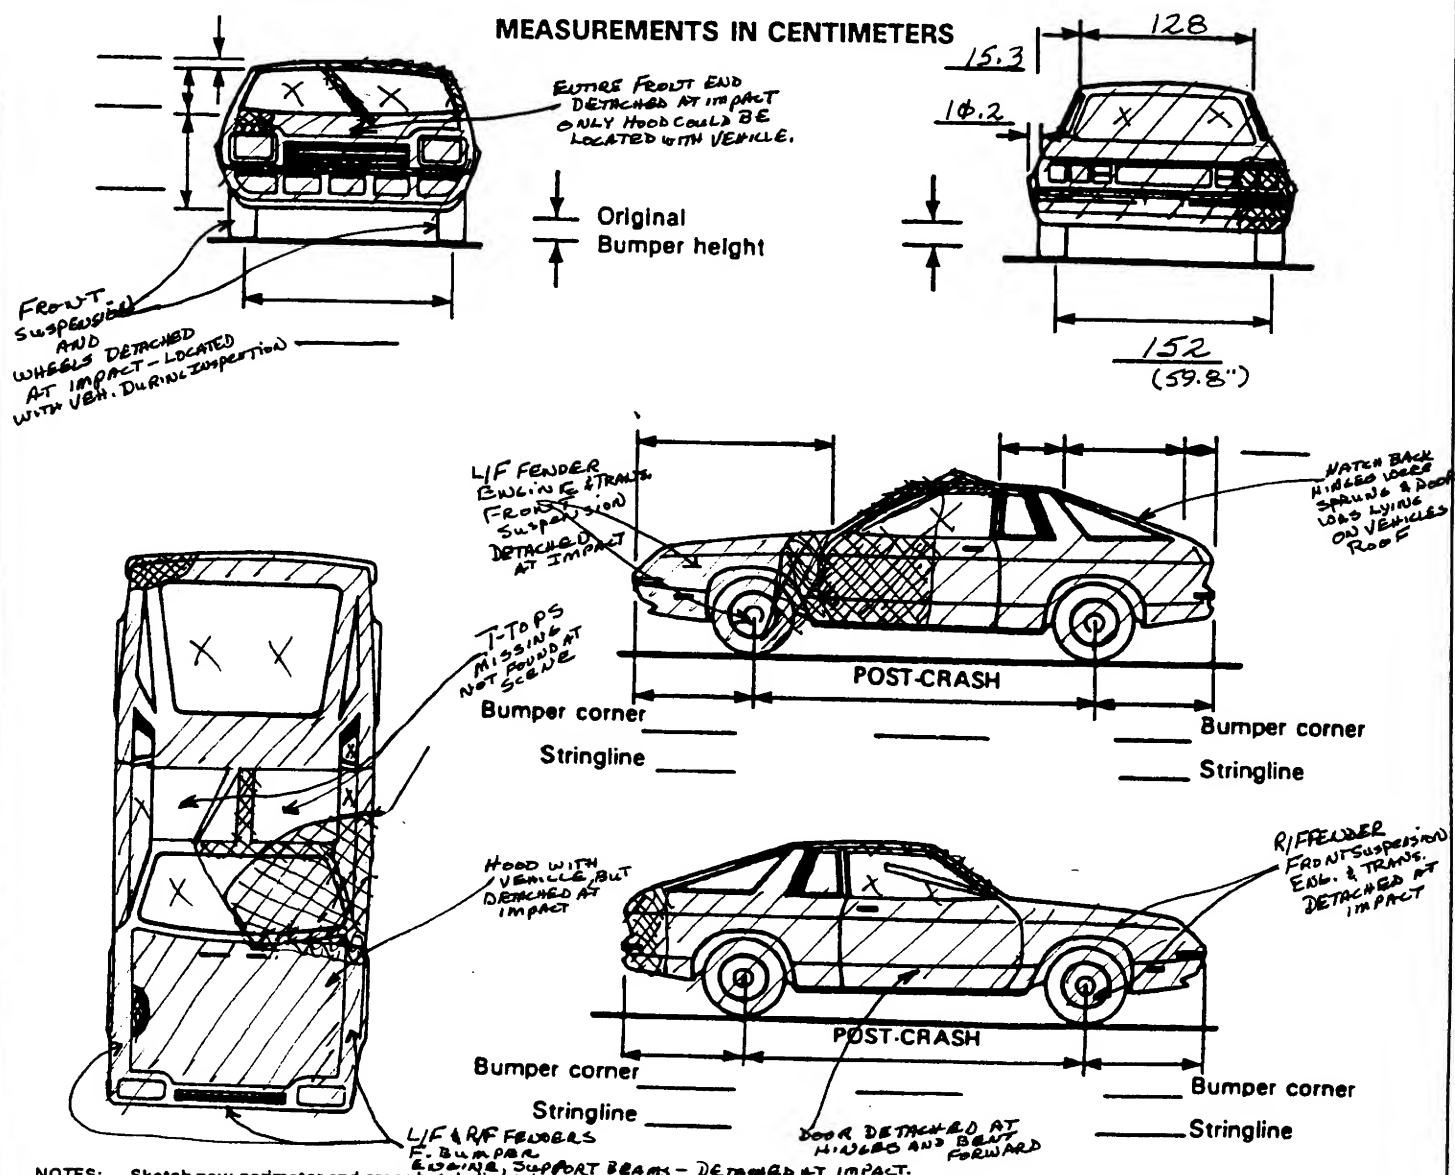
VEHICLE DAMAGE SKETCH

----- NOT MEASURED DUE TO -----
CATASTROPHIC DAMAGE

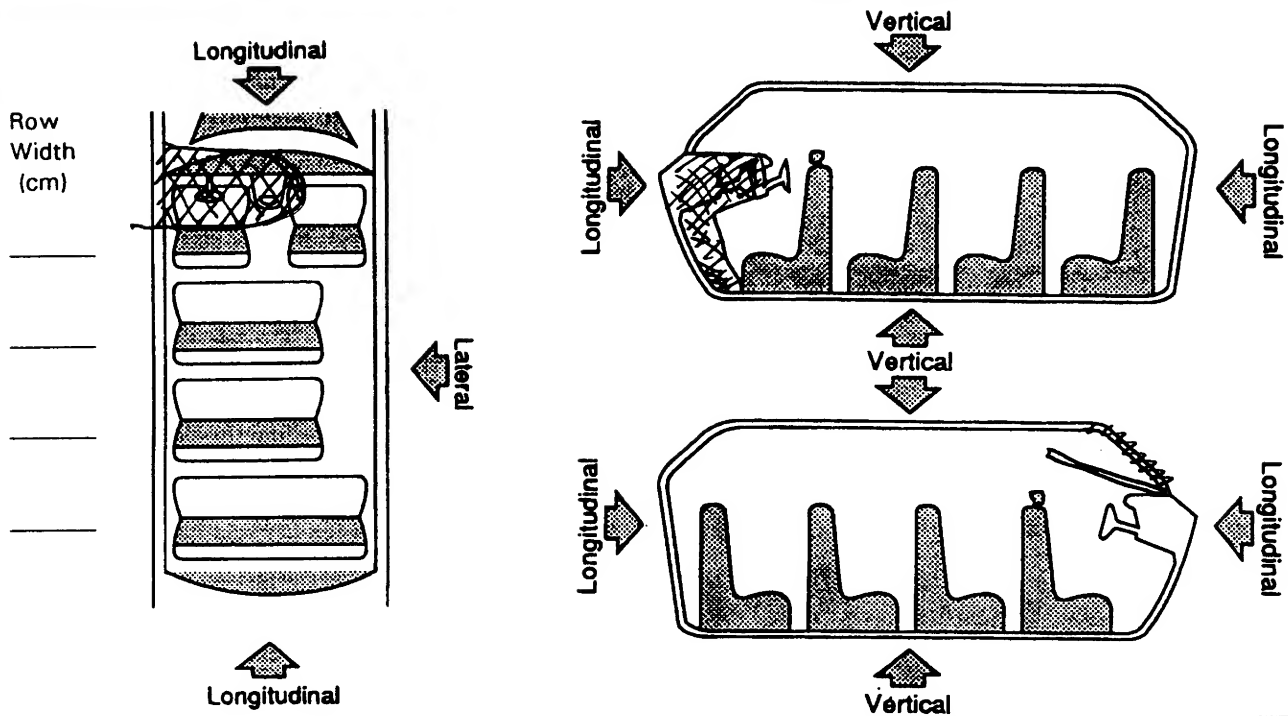
INTRUSION WORKSHEET

LOCATION OF INTRUSION	INTRUDED COMPONENT	(All Measurements Are In Centimeters)			DOMINANT CRUSH DIRECTION
		COMPARISON VALUE	INTRUDED VALUE	INTRUSION	
11	LEFT "A" PILLAR	ϕ	EST. 101.6cm (40")	EST. 101.6cm (40.0")	LATERAL
11	LEFT SILL	ϕ	EST. 101.6cm (40.0")	EST. 101.6cm (40.0")	LATERAL
11	LEFT TOE PAN	ϕ	EST. 101.6cm (40.0")	EST. 101.6cm (40.0")	LATERAL
11	LEFT INST. PANEL	ϕ	EST. 76.2cm (30.0")	EST. 76.2cm (30.0")	LATERAL
11	LEFT INST. PANEL	ϕ	EST. 38.1cm (15.0")	EST. 38.1cm (15.0")	LONG.
13	CENTER CONSOLE	ϕ	EST. 33cm (13.0")	EST. 33cm (13.0")	LATERAL
13	R. FLOOR/TOE PAN	ϕ	EST. 33cm (13.0")	EST. 33cm (13.0")	LATERAL
13	R. "A" PILLAR	ϕ	EST. 27.9cm (11.0")	EST. 27.9cm (11.0")	VERTICAL
11	L. "B" PILLAR	ϕ	EST. 25.4cm (10.0")	EST. 25.4cm (10.0")	LATERAL
13	R. "A" PILLAR	ϕ	EST. 101.2cm (40.0")	EST. 101.2cm (40.0")	LATERAL

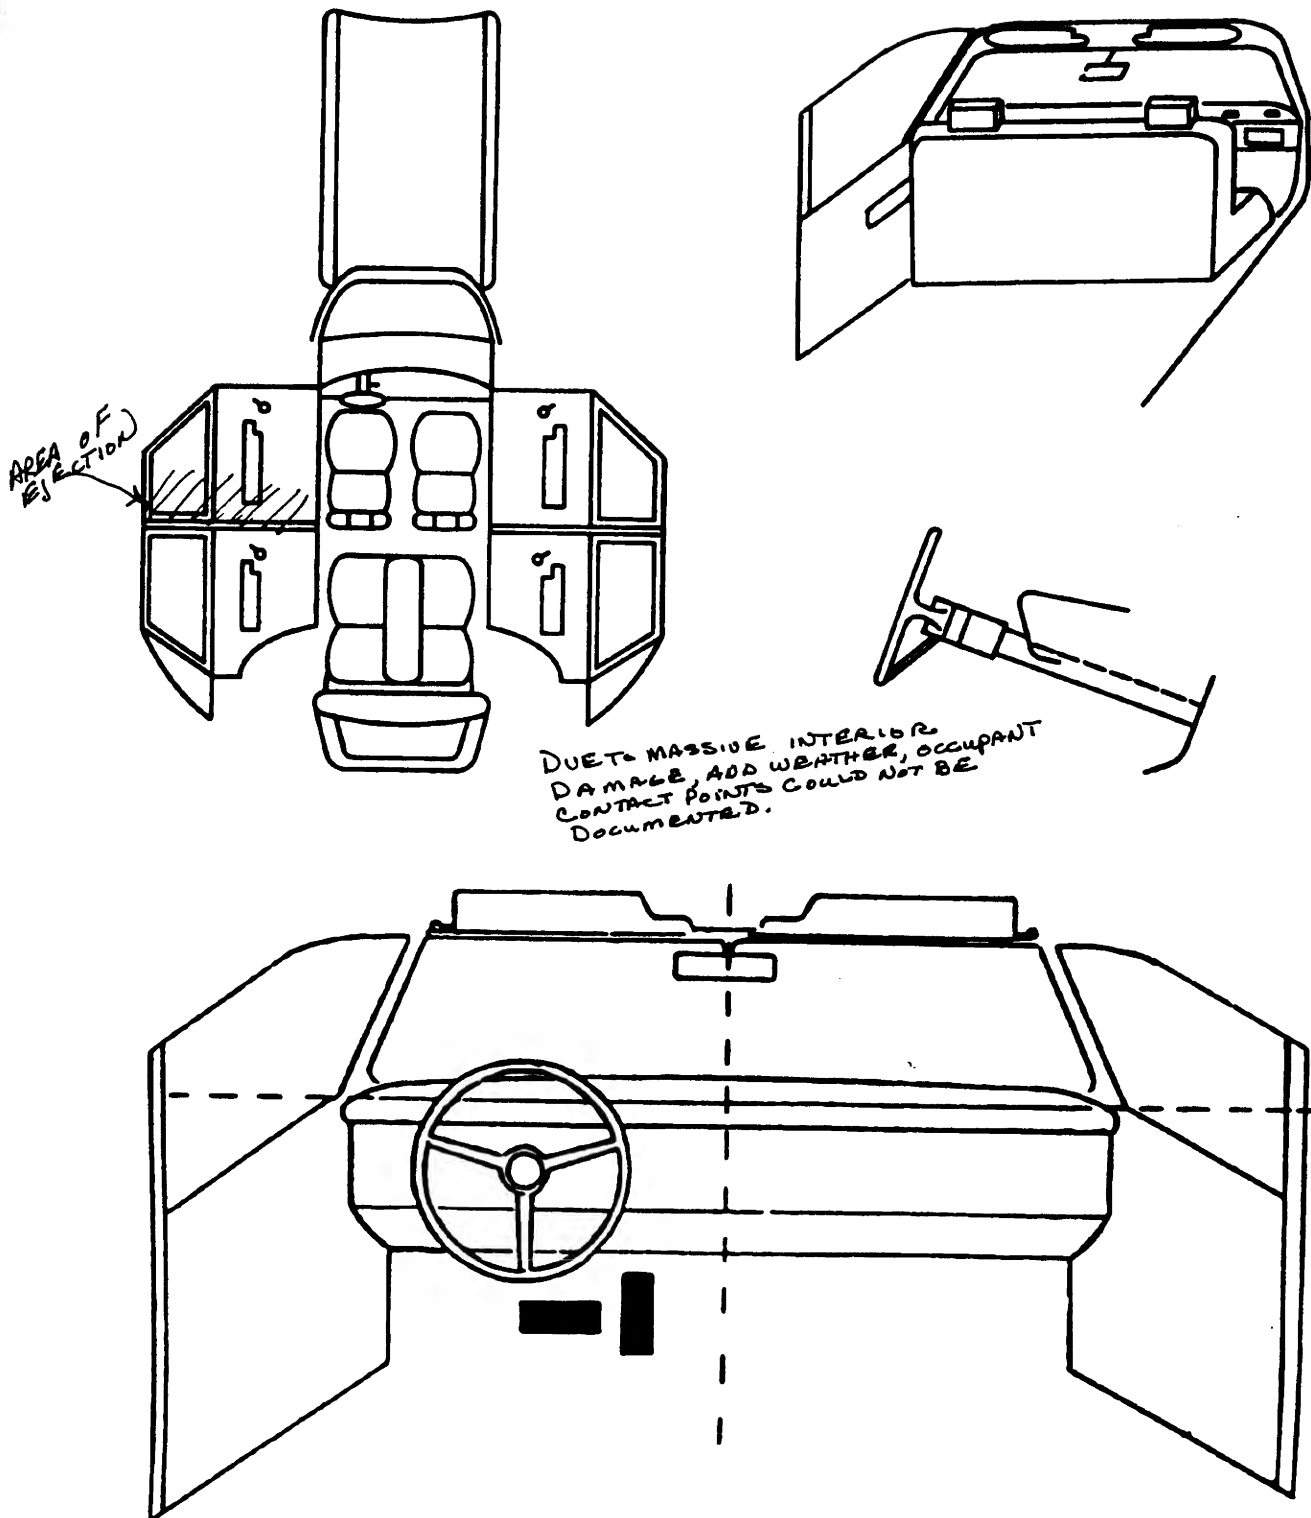
VEHICLE INTERIOR SKETCHES

CONTACT POINTS COULD NOT
BE DOCUMENTED OR IDENTIFIED
DUE TO DAMAGE AND POST ACCIDENT
WEATHER
